# Regulation Roundup

A bulletin for electrical and gas industry workers brought to you by the Office of the Technical Regulator  
**Issue 29 February 2012**

# Electrical Bulletin

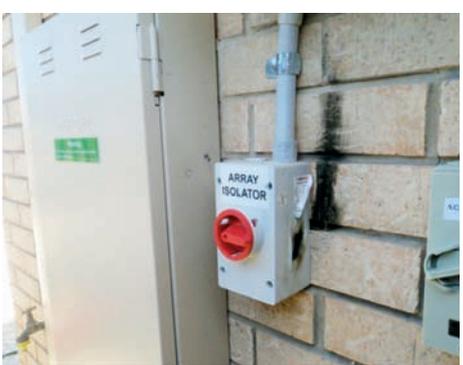
There have been several incidents recorded throughout Australia, (similar incident shown in this photo), where Eltech / Iso-Max dc isolators installed on PV array systems have resulted in a range of failures, including some suspected fires.

If you have installed any of the above dc isolators you are urged to read the bulletin issued by the Australian distributor, Eltech Industries, via their website: <http://www.eltechindustries.com.au/News>

This bulletin details proposed action by installers to replace all affected isolators.

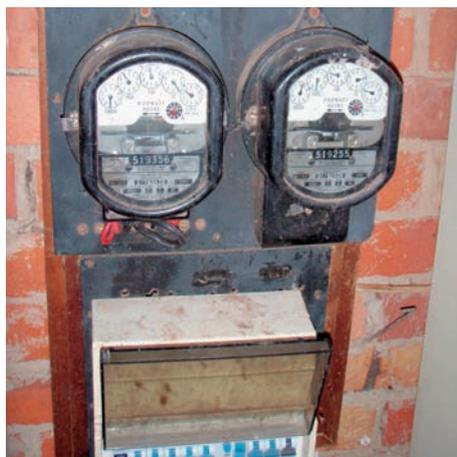
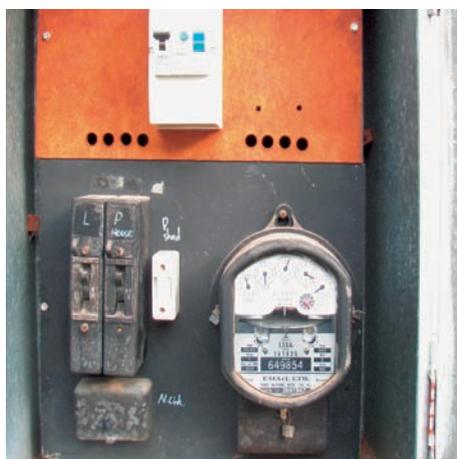
Although Asbestos Containing Materials (ACM) used in panels are usually rough or fibrous and may have a strong tar smell, any black or dark brown switchboard/meter panels pre-dating 1987 may contain up to 20% asbestos. The back of the panel may be stamped as containing asbestos or stamped with a brand name such as Lebah, Zelemite, Miscolite or Ausbestos. The use of all forms of asbestos was banned in 2003 with only a few, very specific, exemptions.

Small amounts of ACM's such as meter or switchboard panels can be safely and legally removed and disposed of without a license, as long as stringent safeguards

are adhered to. SafeWork SA has a handy guide titled 'Asbestos and the Home Renovator' on their website. This guide can be found at the link below, and provides detailed safety procedures and control measures to use when removing and disposing of small amounts of asbestos.

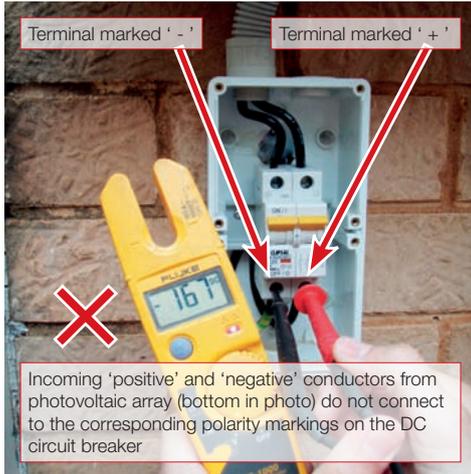
*Polarity sensitive DC circuit breaker wired incorrectly*

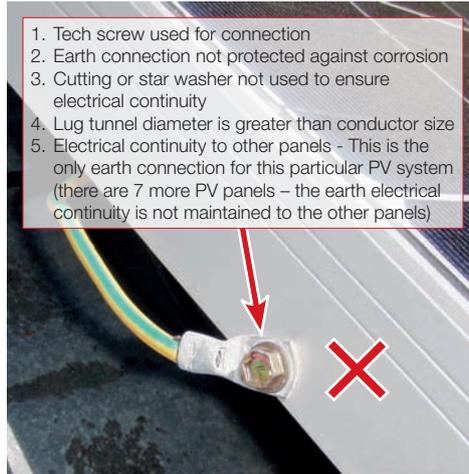
*Inadequate earthing to PV panel*

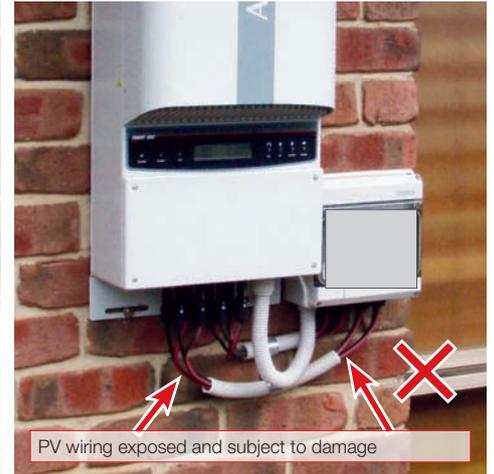
*PV wiring inadequately protected against mechanical damage*

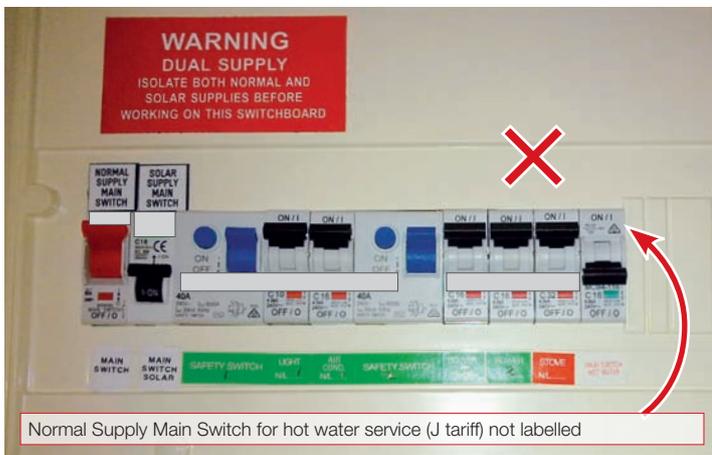
*All main switches not readily distinguishable*

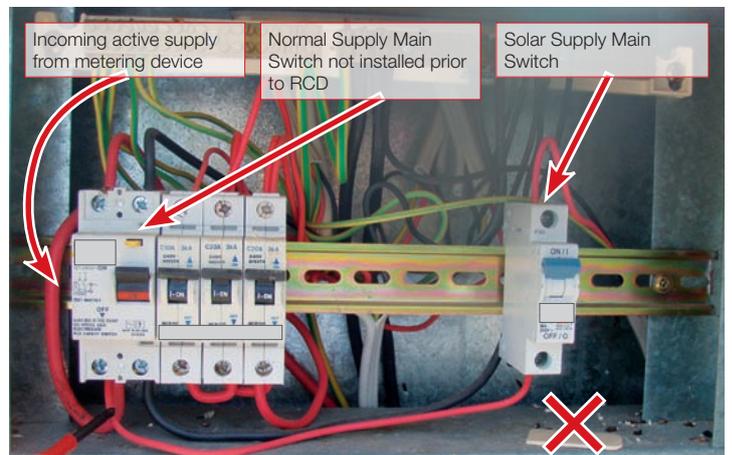
*Electricity supply to inverter is not under the control of a NORMAL SUPPLY MAIN SWITCH*

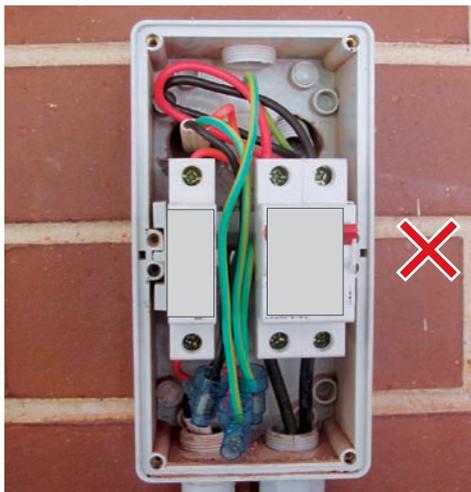
*No segregation between AC & DC wiring in enclosure. Enclosure not sealed against wall to prevent ingress of moisture*

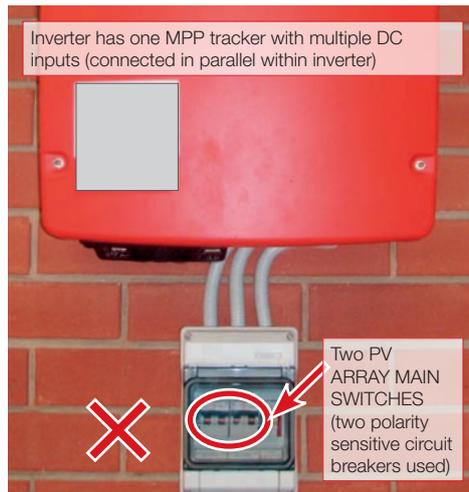
*Two PV strings connected in parallel at inverter - polarity sensitive circuit breaker connected in each PV string*

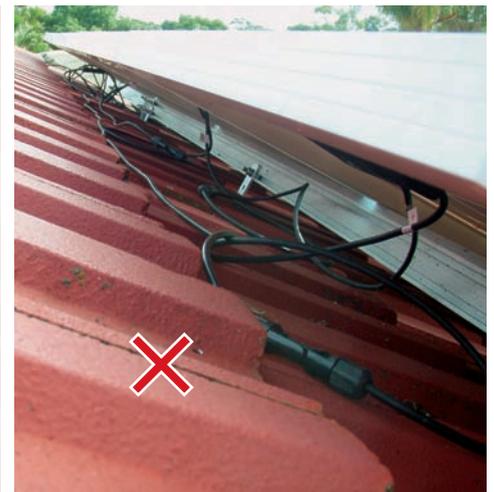
*PV string wiring not fixed in position and laying of roof*

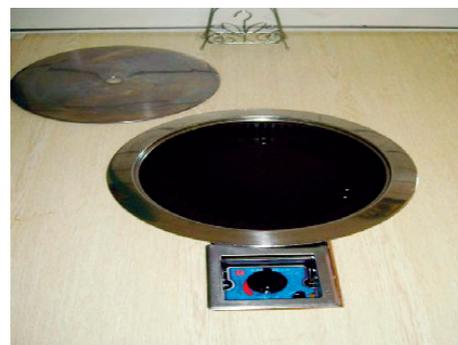
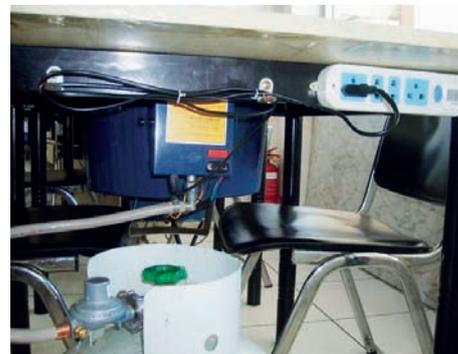
The OTR was contacted by a customer about what he thought was an unsafe gas

installation in a restaurant. Table top gas cookers were uncertified and were connected to individual LPG bottles below each table. The non-approved hoses were secured with worm drive clips and the gas bottles were being used as footrests by customers.

The OTR inspected the installation and the owner was directed to rectify all non compliances and source gas from a fixed external supply.

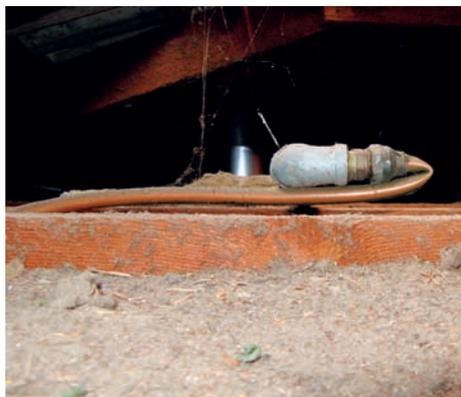
We recently received this photo from a gas fitter who could not believe his eyes when he was investigating a warranty claim on a new gas hotplate. The owner advised him that he had replaced the old gas hotplate on the recommendation of previous gasfitter, as its performance was poor. The new hotplate was even worse hence the warranty call. Looking at this photo one wonders how he was able to cook at all.

Investigations by a more diligent gasfitter showed that a tee had been cut into the existing galv steel outlet in the roof to serve a heater. The installer of that appliance had threaded the steel pipe in situ unwittingly causing the fitting in the picture to turn and crimp the copper supply to the hotplate, restricting supply. So much for fault finding!

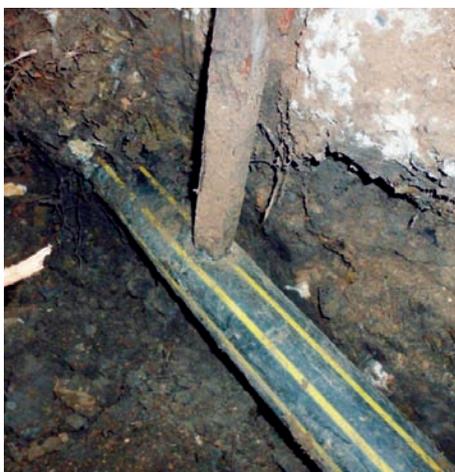
The following photograph shows what happened when a PE gas pipe was laid in a residential multi-dwelling retirement development without proper plans. The system operated at 100kPa on LPG.

The landscapers for this site had accidentally driven a hardwood stake into the gas pipe because they had no idea that there was a gas pipe in the vicinity of their work.

Gas then leaked for nearly ten years before it was detected by a diligent gasfitter who was testing the installation prior to some proposed extensions.

No as-laid plans were produced by the gas contractor when installing the system. No marker tape or tracer wire was provided. Any excavations, repairs or extensions to underground services on the site will need to proceed with great caution.

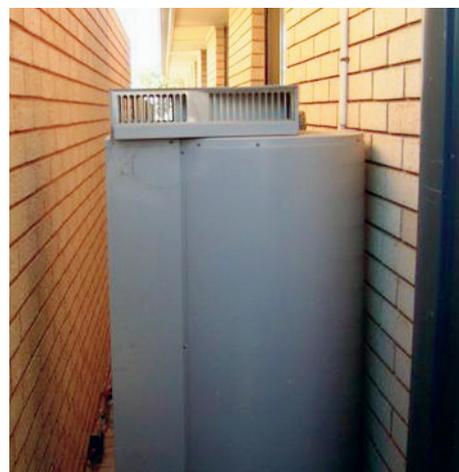
Not only is there restricted ventilation for this storage HWS but how do you service it? The adjacent wall may also cause interference with the flue discharge and combustion emissions which could affect the safety and reliability of the appliance.

Please don't be like this Einstein - ensure you read the site plans before installing appliances to ensure neighbouring structures, including fences, don't restrict access and cause ventilation problems.

Let the builder know early so that alternate installation arrangements can be made to eliminate this by design. The appliance

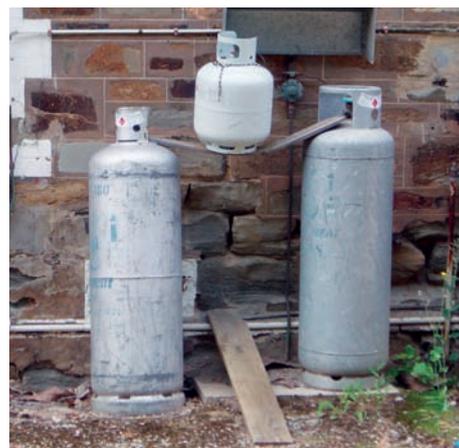
An OTR inspector took this picture recently. All that was stopping the cylinder falling off the plank was a very tired-looking high pressure copper pigtail. You can imagine the effect a ruptured pigtail would have with high pressure LPG venting near the gas hot water unit.

The only good thing we can see here is the built-in gas gauge. The more sag in the plank the more supply you've got!
